Inspection Report

Minerals Regulatory Program

Mine Name: BMC Seep Ridge Road	Permit Number: S/47/0119	Permit Fees: Delinquent
Operator Name: Blue Mtn Crushing	Inspection Date: 03/31/2015	Bond Amount: \$62,200.00
Inspector(s): A. Abate	Time: 9:30 AM	Bond Escalation: 7/27/2015
Others:	Mine Status: Abandoned

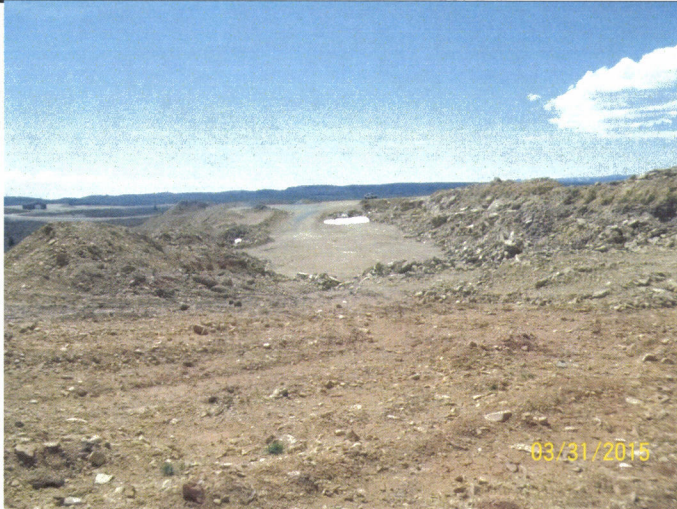
Overview of the mine facing southwest. Graded pad is shown where the mine entry was located off Seep Ridge Road.

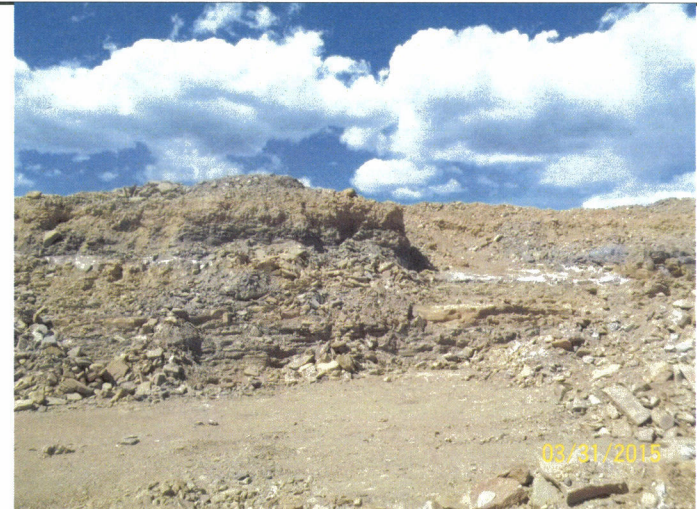
View of the active mine area facing north. Rock has been pushed up in piles.

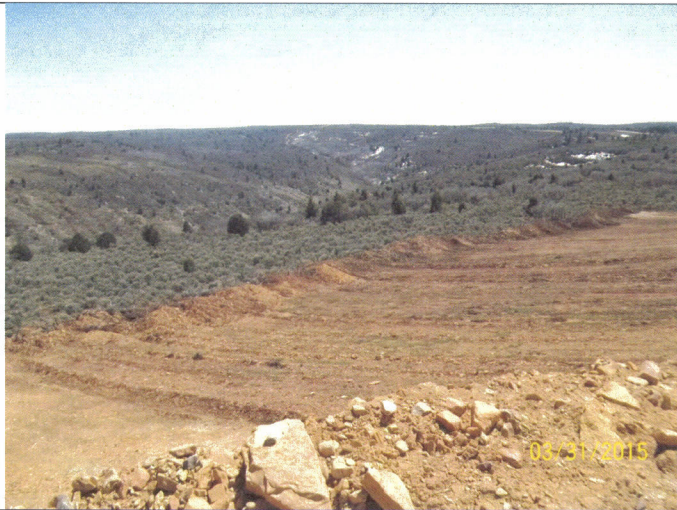
Topsoil appears to have been pushed toward the east and forms a berm to the east of the permit area. View looking southeast.

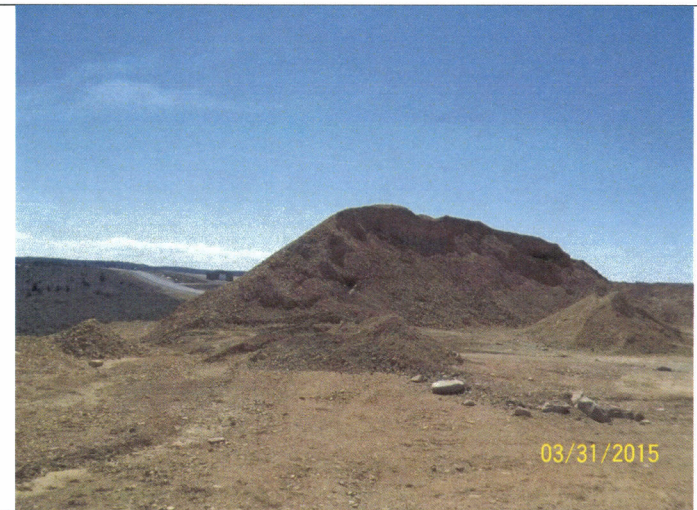
A stockpile of crushed rock was located on the southern end of the permit area adjacent to Seep Ridge Road.
